Accessible Parking - Countess of Chester Hospital

The current position - Observations 9/2/17 - 1.40 pm

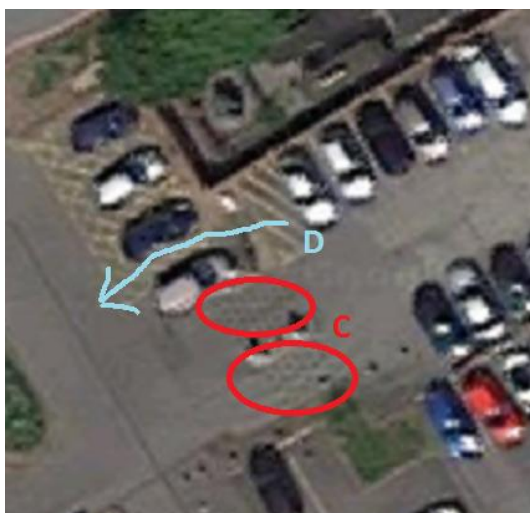
Below are two photographs one a cropped version of the aerial view. Areas marked 'C' indicates the former position of the barriers on this car park prior to removal, however, it is noted that large rubber bobbles remain fixed to the tarmac shown in the second photograph.

The route marked in blue; 'D' on the photograph shows the route taken via the short path - the normal route out of this car park for someone in a wheelchair or powered scooter and has dropped kerb access.

It is noted, however, from this and site observations that there is no actual marked crossing at this point and that traffic flow here comes from the rear-right (following the one way system) and rear-left off the car park itself.

It should also be noted that this is the only area of dropped kerb for approximately 100m on the car park side of the area. The area with rubber bobbles is not a particularly safe area as cars are constantly moving across what is quite a narrow cut through.

- Removal of Plastic/rubber bobbles at entrance to car park and make good surface area.
- Prevent parking in hashed area near to dropped kerb footpath by installing immovable bollard(s)
- Consider the difficulties of individuals with a disability crossing the road at this point with no marked crossing visible.
- Provide a greater number of correctly marked disabled spaces.
- Reserved spaces should be clearly designated for use by people with disabilities and

- *I will link up with our Estates Manager regarding the removal of the rubber discs as a matter of priority and ascertain a designated crossing point.*

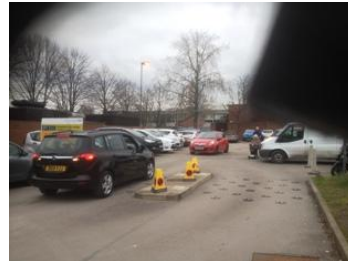
Car park use - At the time of my visit the car park was full - visitors were actually queuing to find a space. All spaces were taken people waited for spaces to become available. **Eight of the 20 or so cars on the parking lot failed to display a disabled badge.**

The photographs above show queuing traffic actually blocking the point at which a wheelchair would normally cross the road. **This is significant as during my time on site I saw a number of vehicles reversing in this area when the drivers realised that the car park was full.** The red car in the picture above was simply 'hovering' moving forwards and backwards waiting for a space to become available.

- Much stricter enforcement of parking - clamping should be considered.

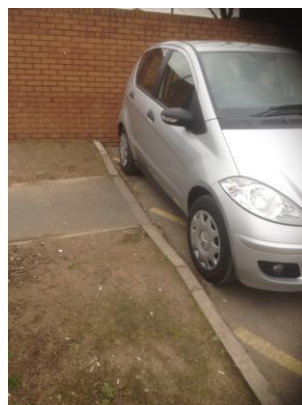
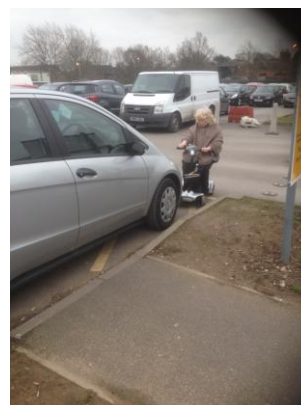
Access - This was somewhat difficult. At the time of my visit a car was parked in the cross hatched area next to the path providing dropped kerb access. This confirmed some of the anecdotal evidence we had received. A passer-by who told me that he visited the hospital at least once a week told me ***"There's always something parked there!"***

One lady had a small power scooter had real problems demonstrated by the second photograph. With her access blocked to the much needed path. She did not want to risk going over the large car sized bobbles on the entrance for fear of tipping over.
